**CITY OF BALTIMORE WET WEATHER CONSENT DECREE  
SMOKE AND DYED WATER TESTING FORM**

Sewershed: Low Level  
Subsewershed: 42

**CITY OF BALTIMORE**  
**SMOKE TESTING OBSERVATION SUMMARY**  
**LOW LEVEL SEWERSHED**  
BALTIMORE CITY PROJECT 1029  
REI/DRAYCO

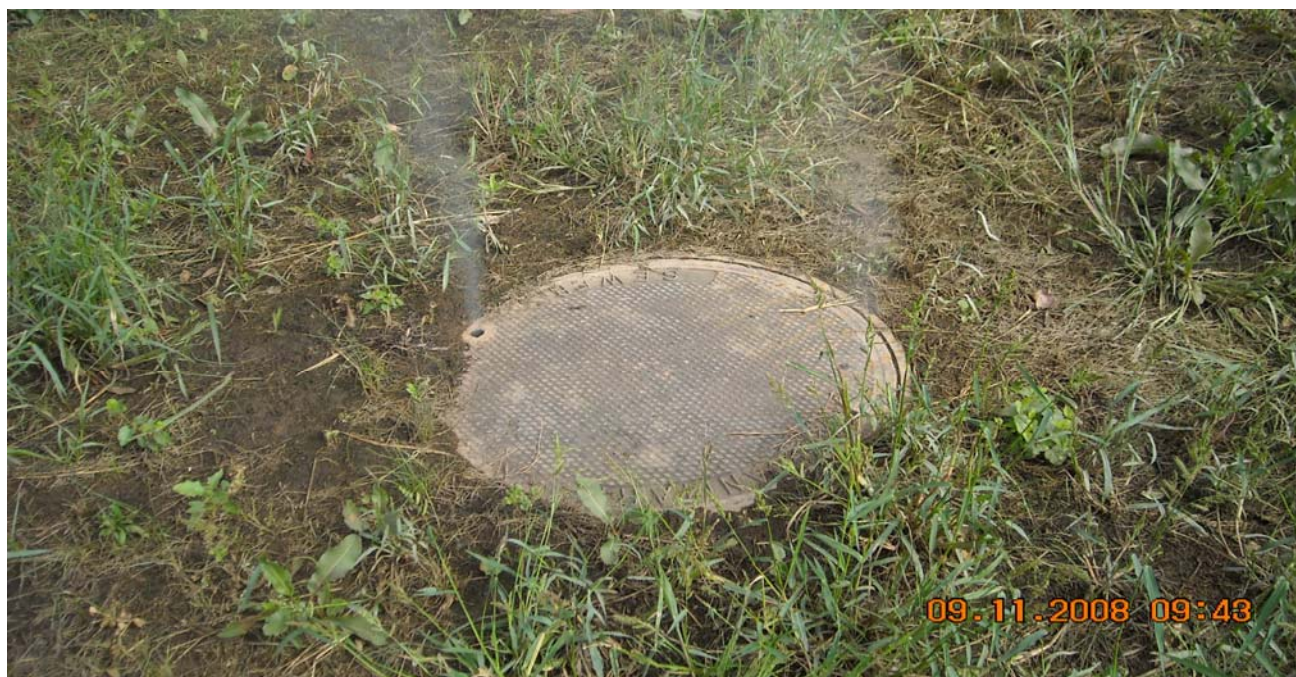
Photograph No: OB01-01  
Filename: 1029-546\_OB01-01.jpg

Unique Test ID: 546	Date: 09/11/2008	Basin: LL - 42	Manhole ID: S21W__021MH
Defect No: OB01	Supervisor: E.R.	Crew: 04	Dye Test Recommended: N
Location: S19W__024MH			
Source Type: 01 Main Sewer		Location: 11 Field/Woods	
Sector: 01 Public		Severity: 03 Moderate	Drainage Area: 0
Comments: THIS IS ABANDONED MANHOLE S19W__024MH AND IT SMOKED WHEN BLOWING FROM S21W__021MH.

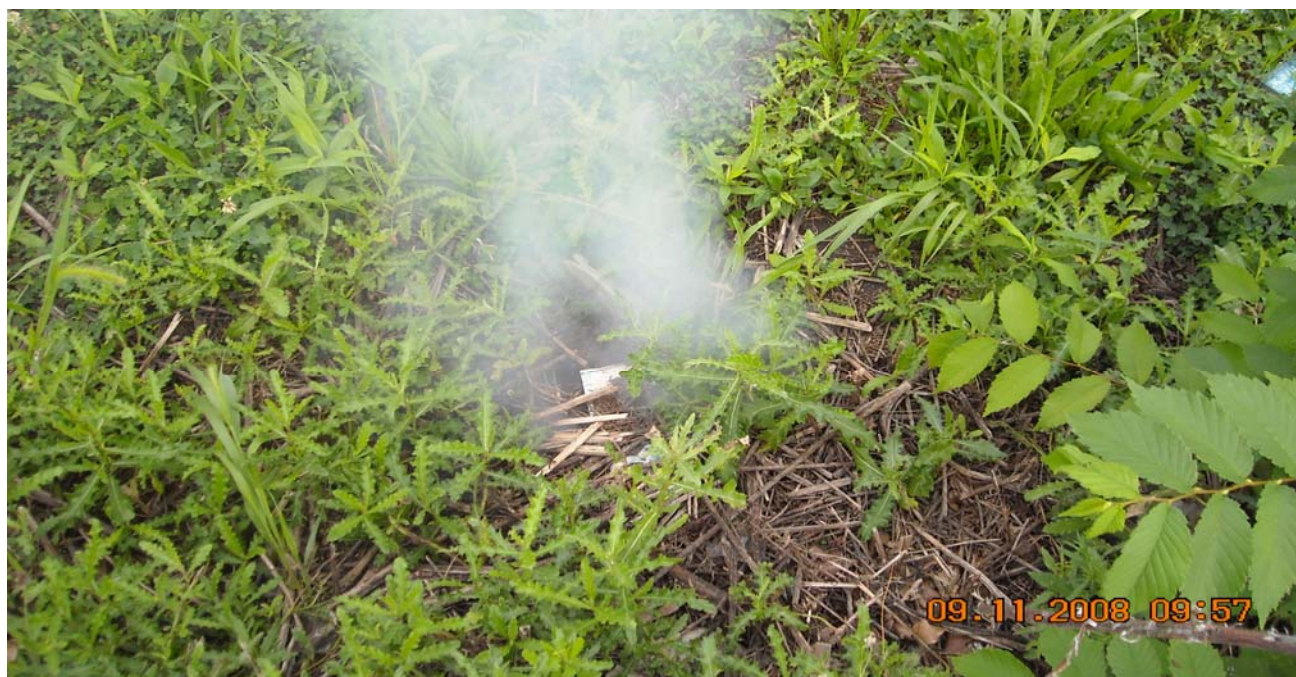
Photograph No: OB02-01  
Filename: 1029-546\_OB02-01.jpg

Unique Test ID: 546	Date: 09/11/2008	Basin: LL - 42	Manhole ID: S21W__021MH
Defect No: OB02	Supervisor: E.R.	Crew: 04	Dye Test Recommended: N
Location: 2356 WASHINGTON BLVD.			
Source Type: 02 Service Line		Location: 11 Field/Woods	
Sector: 02 Private		Severity: 03 Moderate	Drainage Area: 1
Comments: SMOKE COMING FROM GROUND IN FIELD.

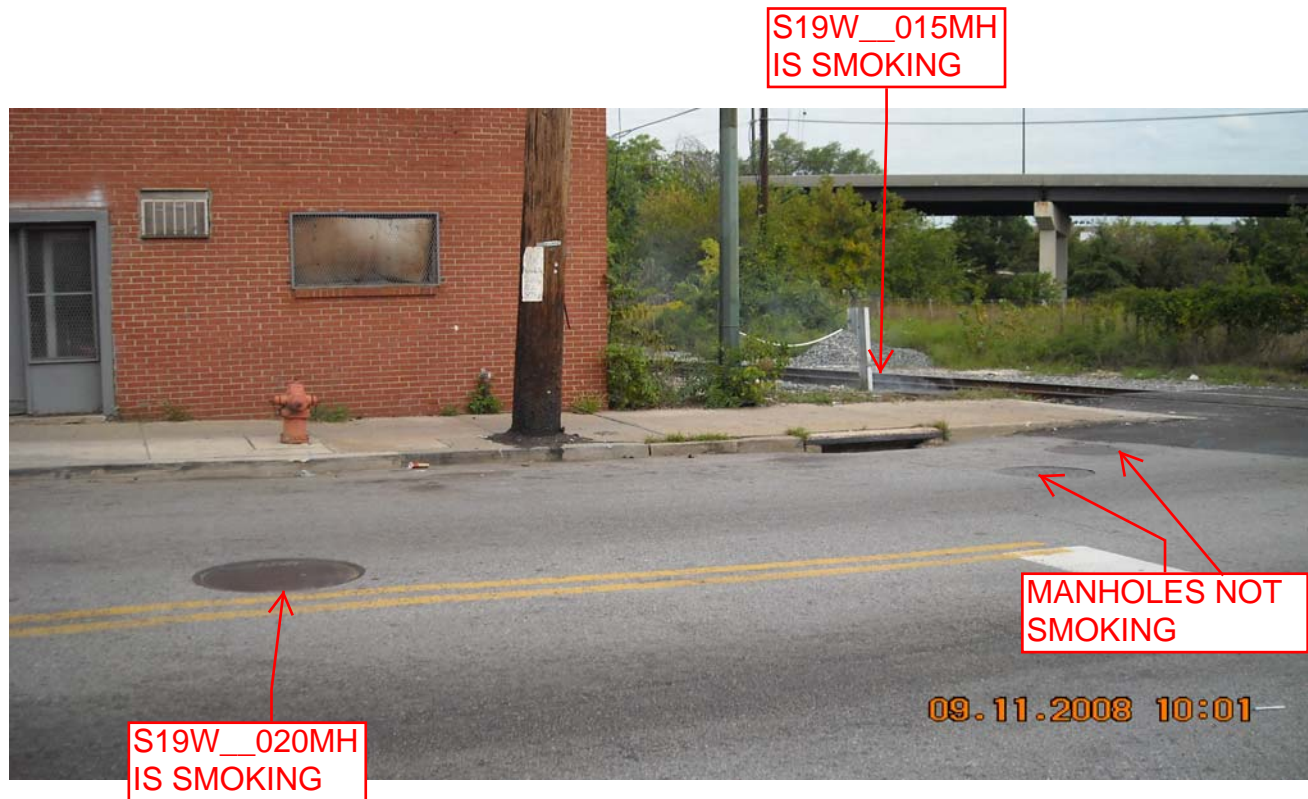
Photograph No: OB03-01  
Filename: 1029-546\_OB03-01.jpg

Severity: 03 Moderate

Comments: SMOKE COMING FROM S19W\_\_015MH WHICH MUST BE CONNECTED TO S19W\_\_020MH  
ALTHOUGH NO CONNECTION IS SHOWN ON MAP. CANNOT LOCATE S19W\_\_021MH. THE MANHOLES  
HERE ARE FOR WATER VALVES.
